Streamflow Changes of Dajia River Associated with Chi-Chi Earthquake

Youe-Ping Lee

Water Resources Agency, Ministry of Economic Affairs,
Taiwan, R.O.C.

September 24, 2002

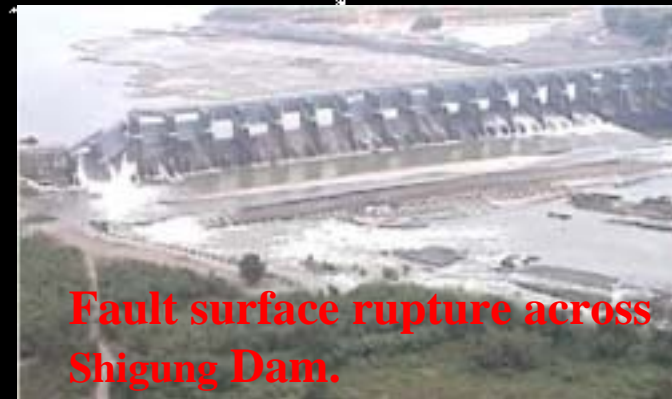
Fault surface rupture across Shigung Dam.

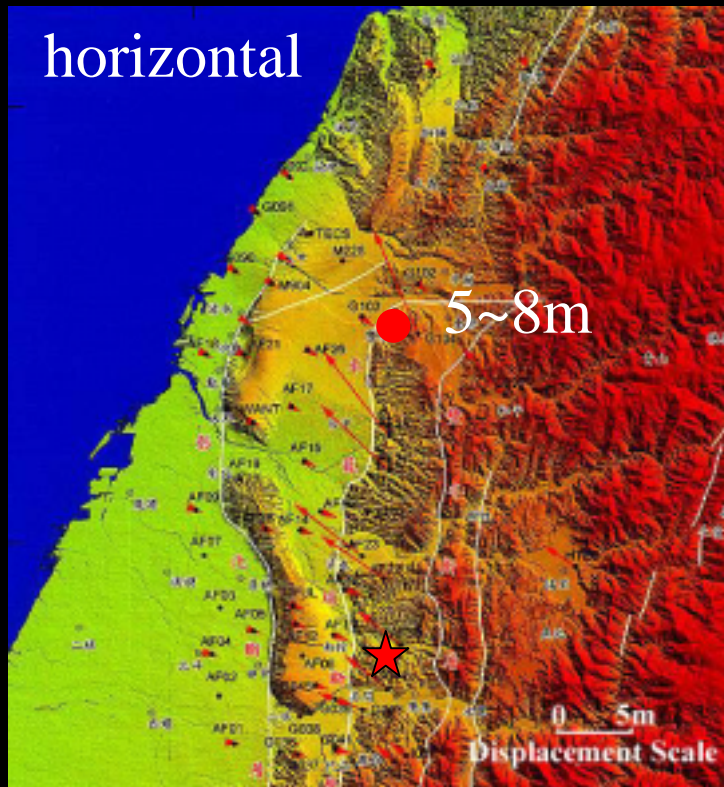
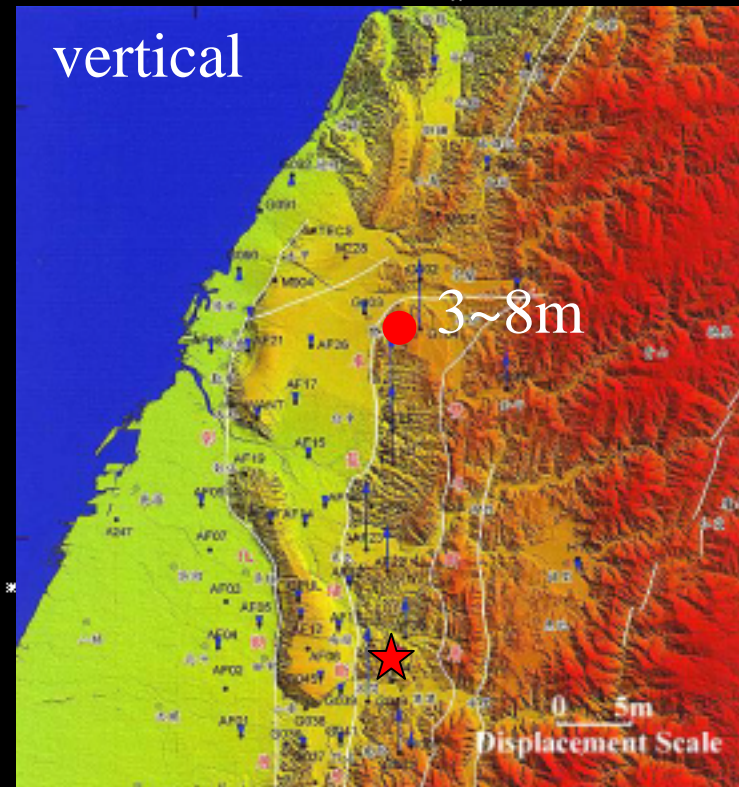
DEFORMATION of STUDY AREA

- ✦ Geographically, the Dajia river basin is penetrated by the Chelungpu fault and stroke by the Chi-Chi earthquake with severe crustal deformation.
- ✦ The horizontal displacement in the vicinity of the Shigung dam is 5~8m, and the vertical displacement is 3~8m.

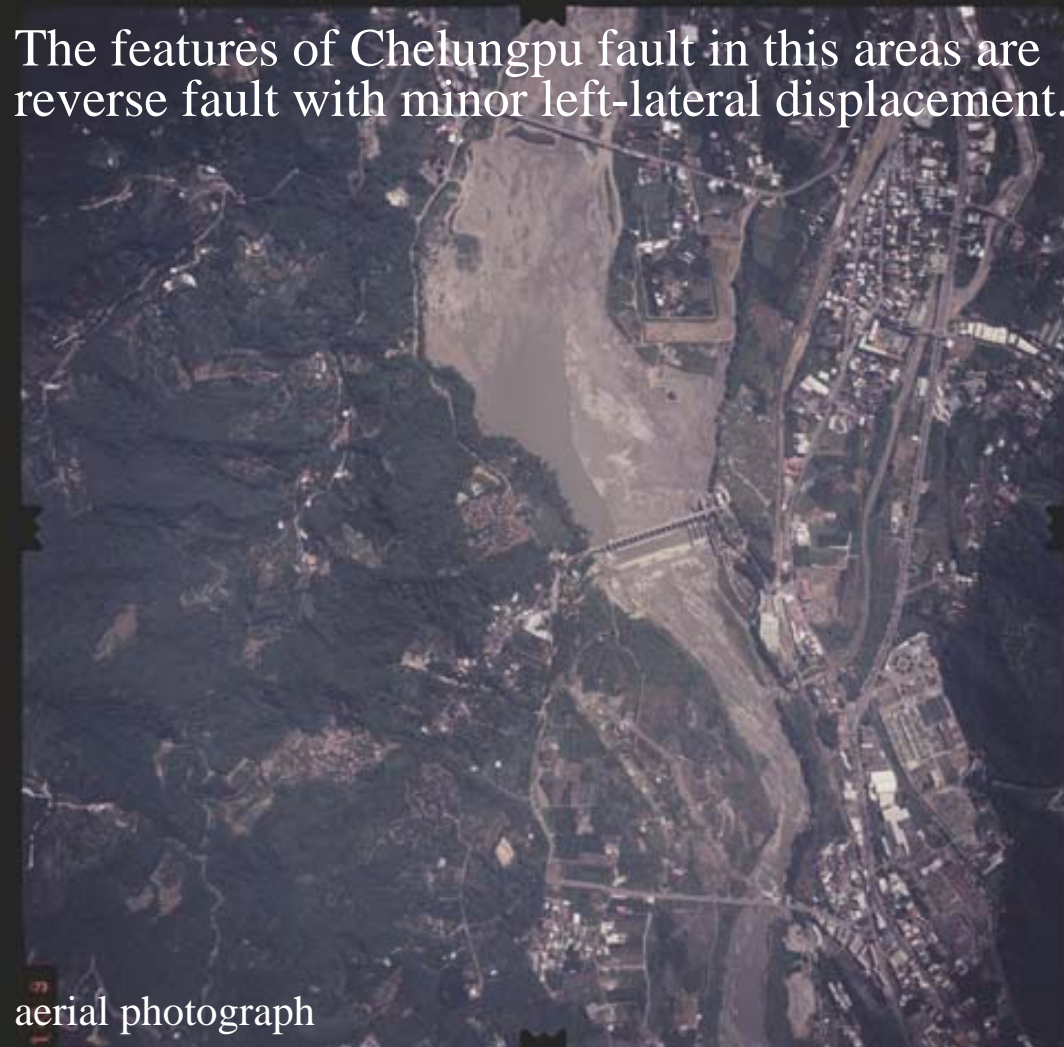
aerial photograph

The features of Chelungpu fault in this areas are reverse fault with minor left-lateral displacement.

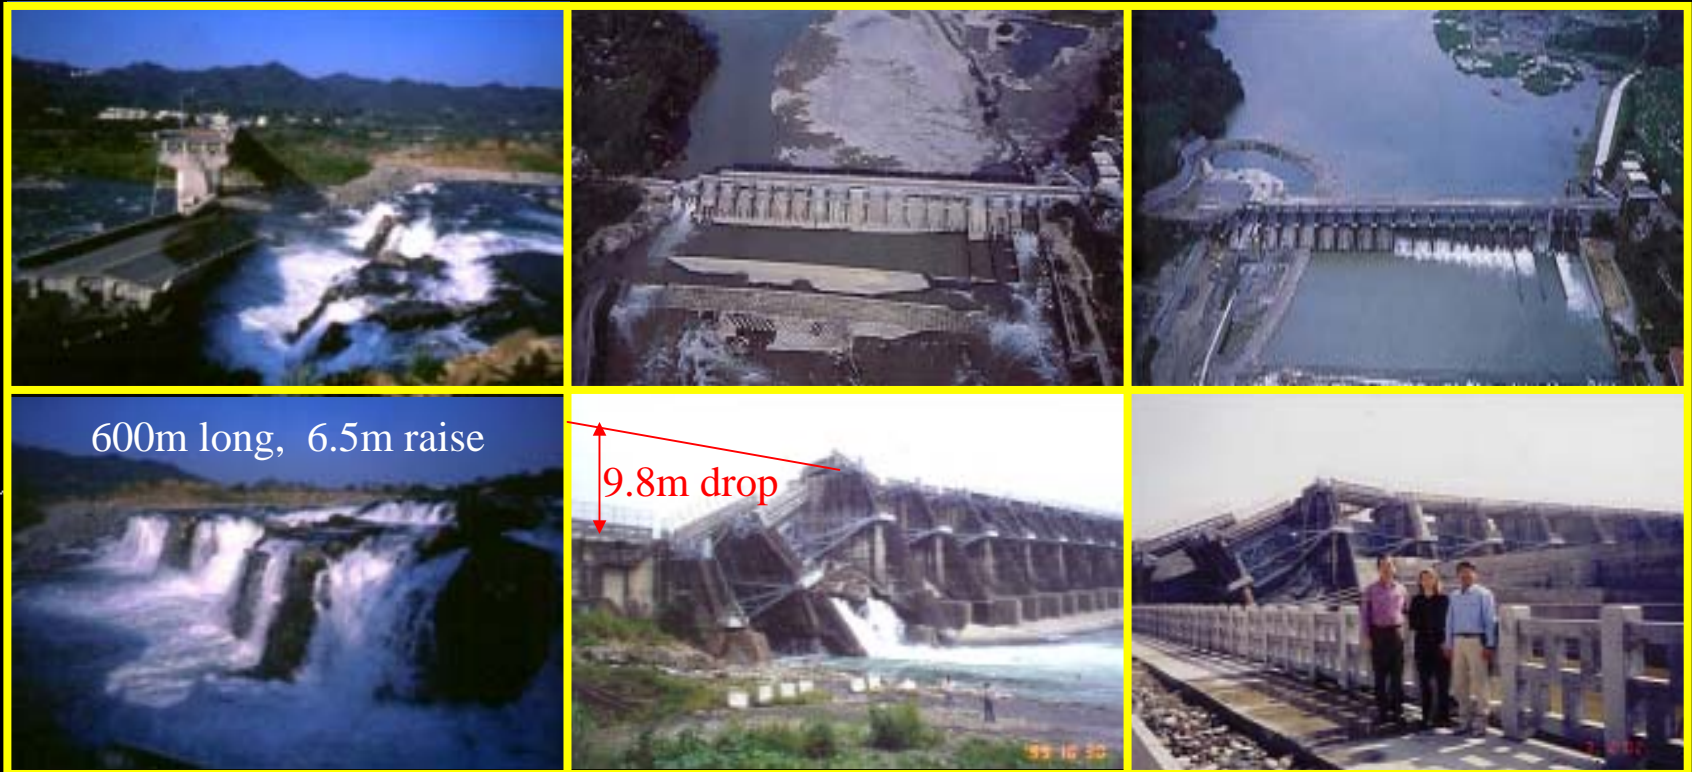
DAMAGE of SHIGUNG DAM

- ✦ The Chi-Chi earthquake destroys the Shigung dam.
- ✦ The effective storage is reduced to 1.35 million m³, which is 50% of the designed storage.

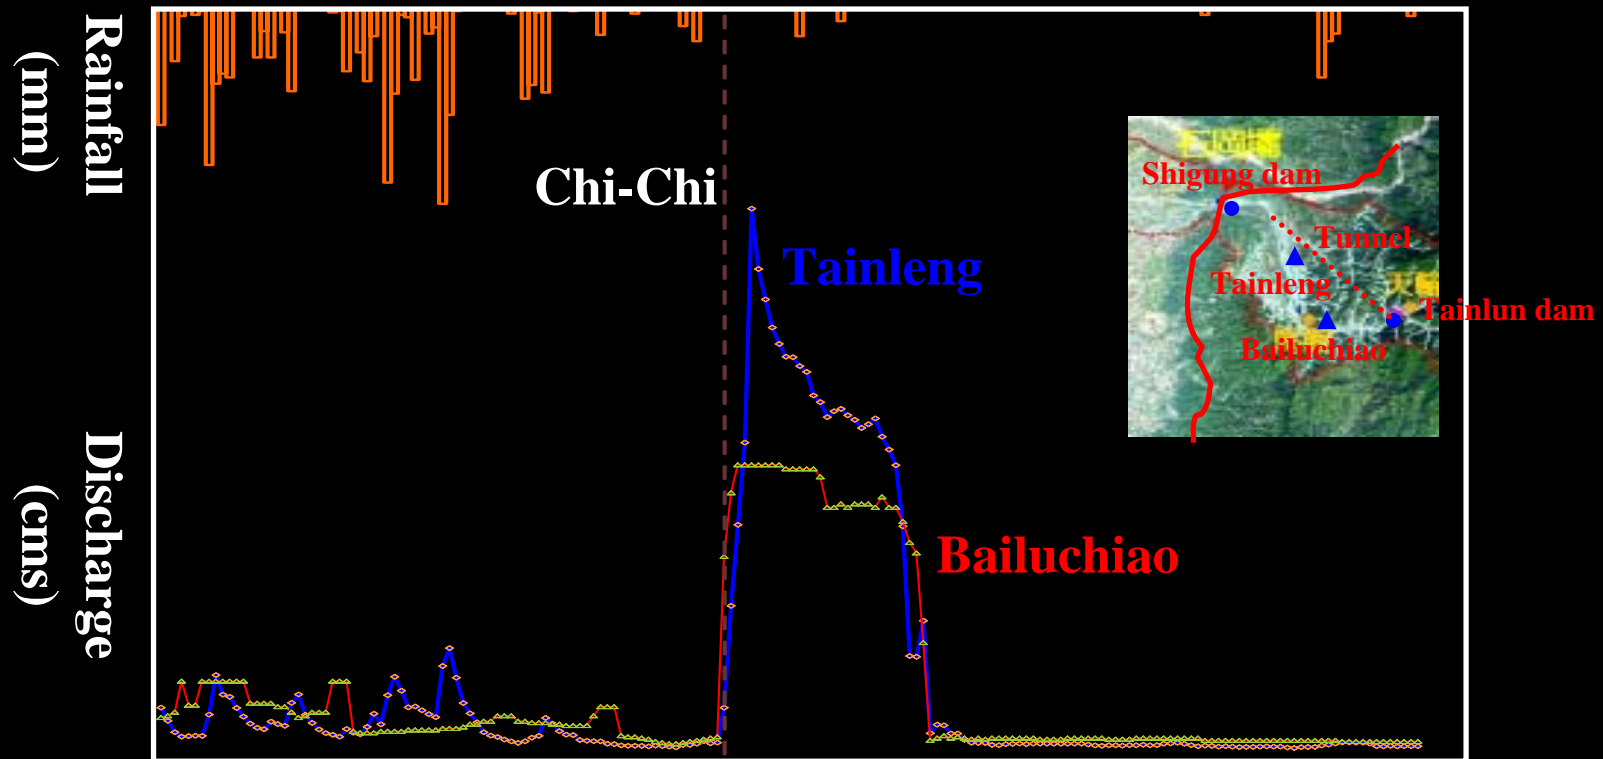
STREAMFLOW CHANGES

- ✦ The discharges had co-seismically increased since the hydraulic power station shut down.
- ✦ Although the total precipitation is only 180mm in that month and there is no other branch inflow between these two gauging stations, the discharge of Tainleng gauging station is much larger than Bailuchiao gauging station.

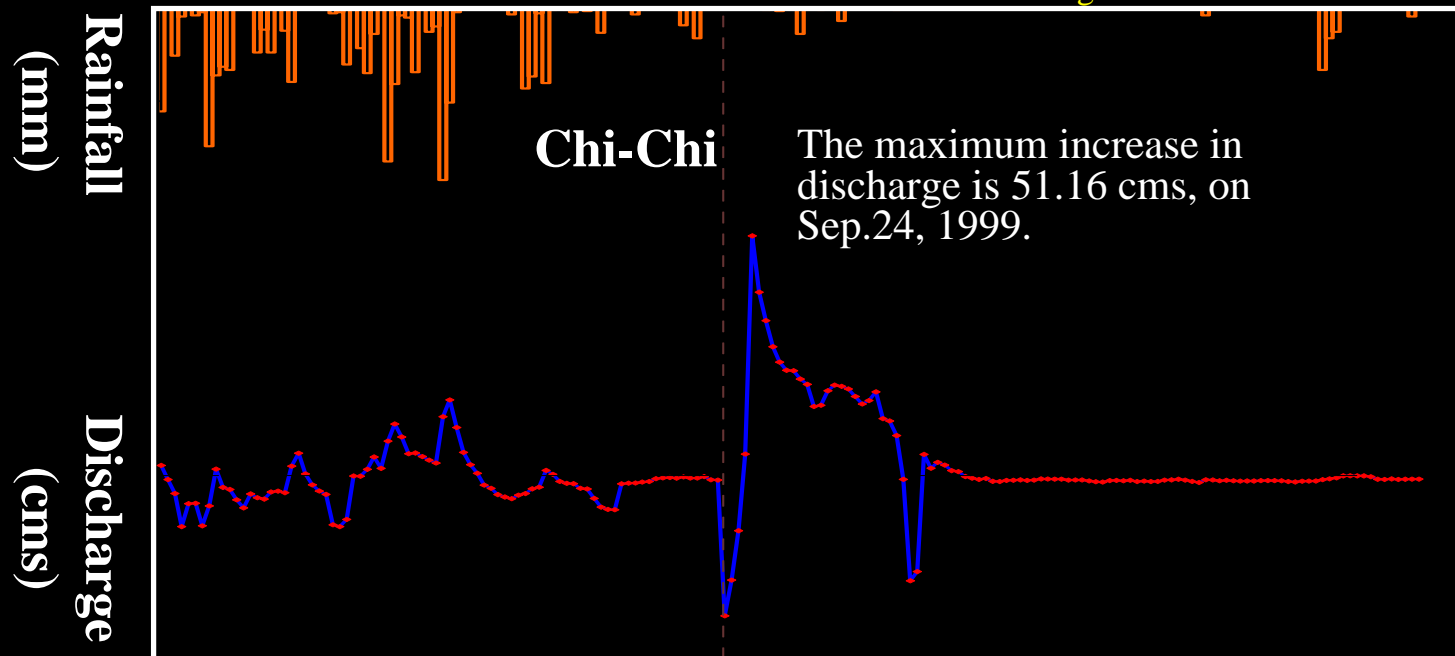
The difference of the discharges between those two streamflow gauging stations (ie. $Q_{\text{Taileng}} - Q_{\text{Bailuchiao}}$).

- ✦ The amount of this anomalistic excess-streamflow is about 21.7million m^3 in one month after earthquake.
- ✦ The residents in the vicinity of the Shigung dam also reported that some wells had lost water and the yields had significantly decreased after earthquake.
- ✦ Unfortunately, we don't have any observational well in that area.
- ✦ The excess-streamflow maybe come from the groundwater.
