Coseismic surface deformation and engineering damage associated with the large strike-slip faulting: Lessons from the 2001 Mw 7.8 Central Kunlun earthquake

Abstract: We analyzed coseismic surface deformations associated with the 2001 Mw 7.8 Central Kunlun earthquake, which occurred on 14 November 2001 along the west (Kusai Lake) segment of the left-lateral strike-slip Kunlun fault in northern Tibet, China. Field investigations and analyses of satellite remote sensing imagery indicate that a 400-km-long coseismic rupture zone occurred along the pre-existing Kunlun fault zone. The coseismic surface rupture zone is mainly composed of sinistral shear faults, tensional cracks, mole tracks, and pull-apart sag ponds and grabens. Width of the coseismic surface rupture zone ranges from several meters to 1 km. This earthquake caused damage to the highway between Golmud and Lhasa, base of the Qinghai-Tibet railway, and temporary housing for railway construction workers. It also triggered snow and glacier avalanches. The analyses of coseismic surface deformational features and engineering damage provide us useful experience to evaluate possible engineering damage associated with future great

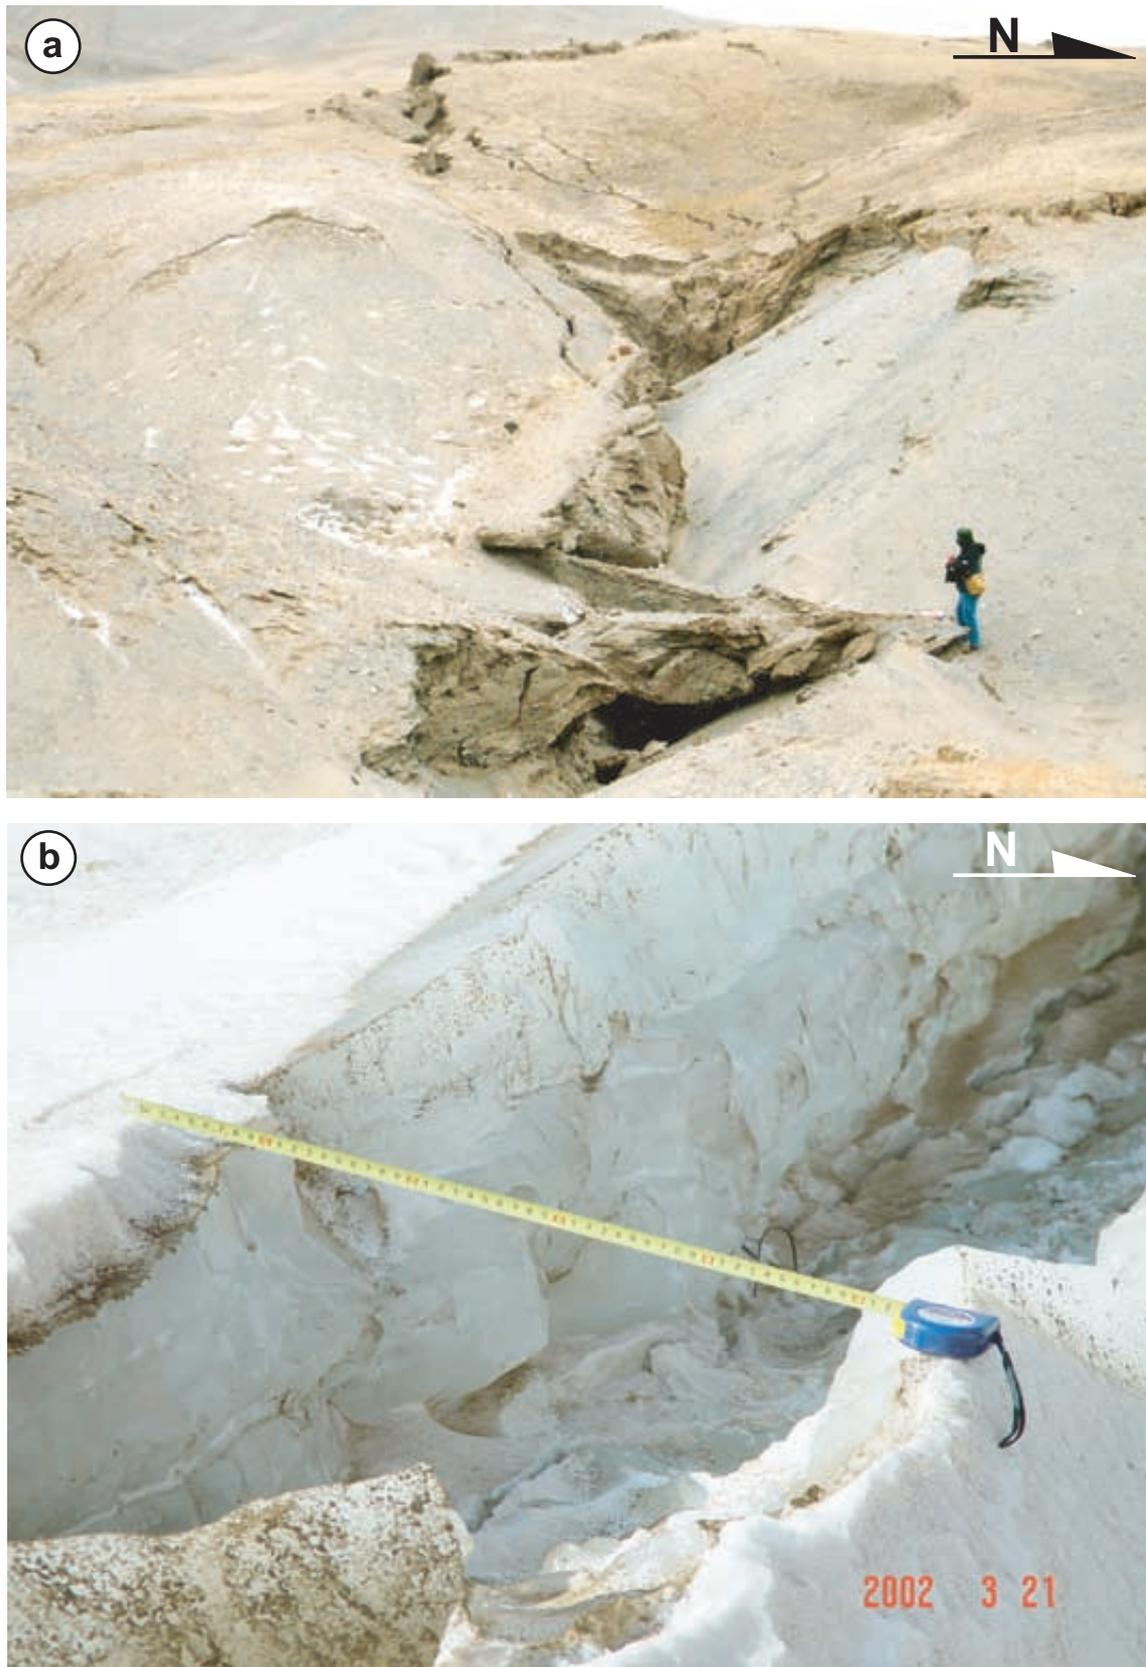
Fig. 5. Tensional structures found along the rupture zone. (a) Opening cracks produced by the lateral displacement near Site 8. See the person for the scale. (b) A tensional crack about 50 cm wide on the frozen surface of Kushuiwan Lake, at the westernmost end (Site1) of the coseismic rupture zone. See Fig. 1b for the locations of Sites 1 and 8.

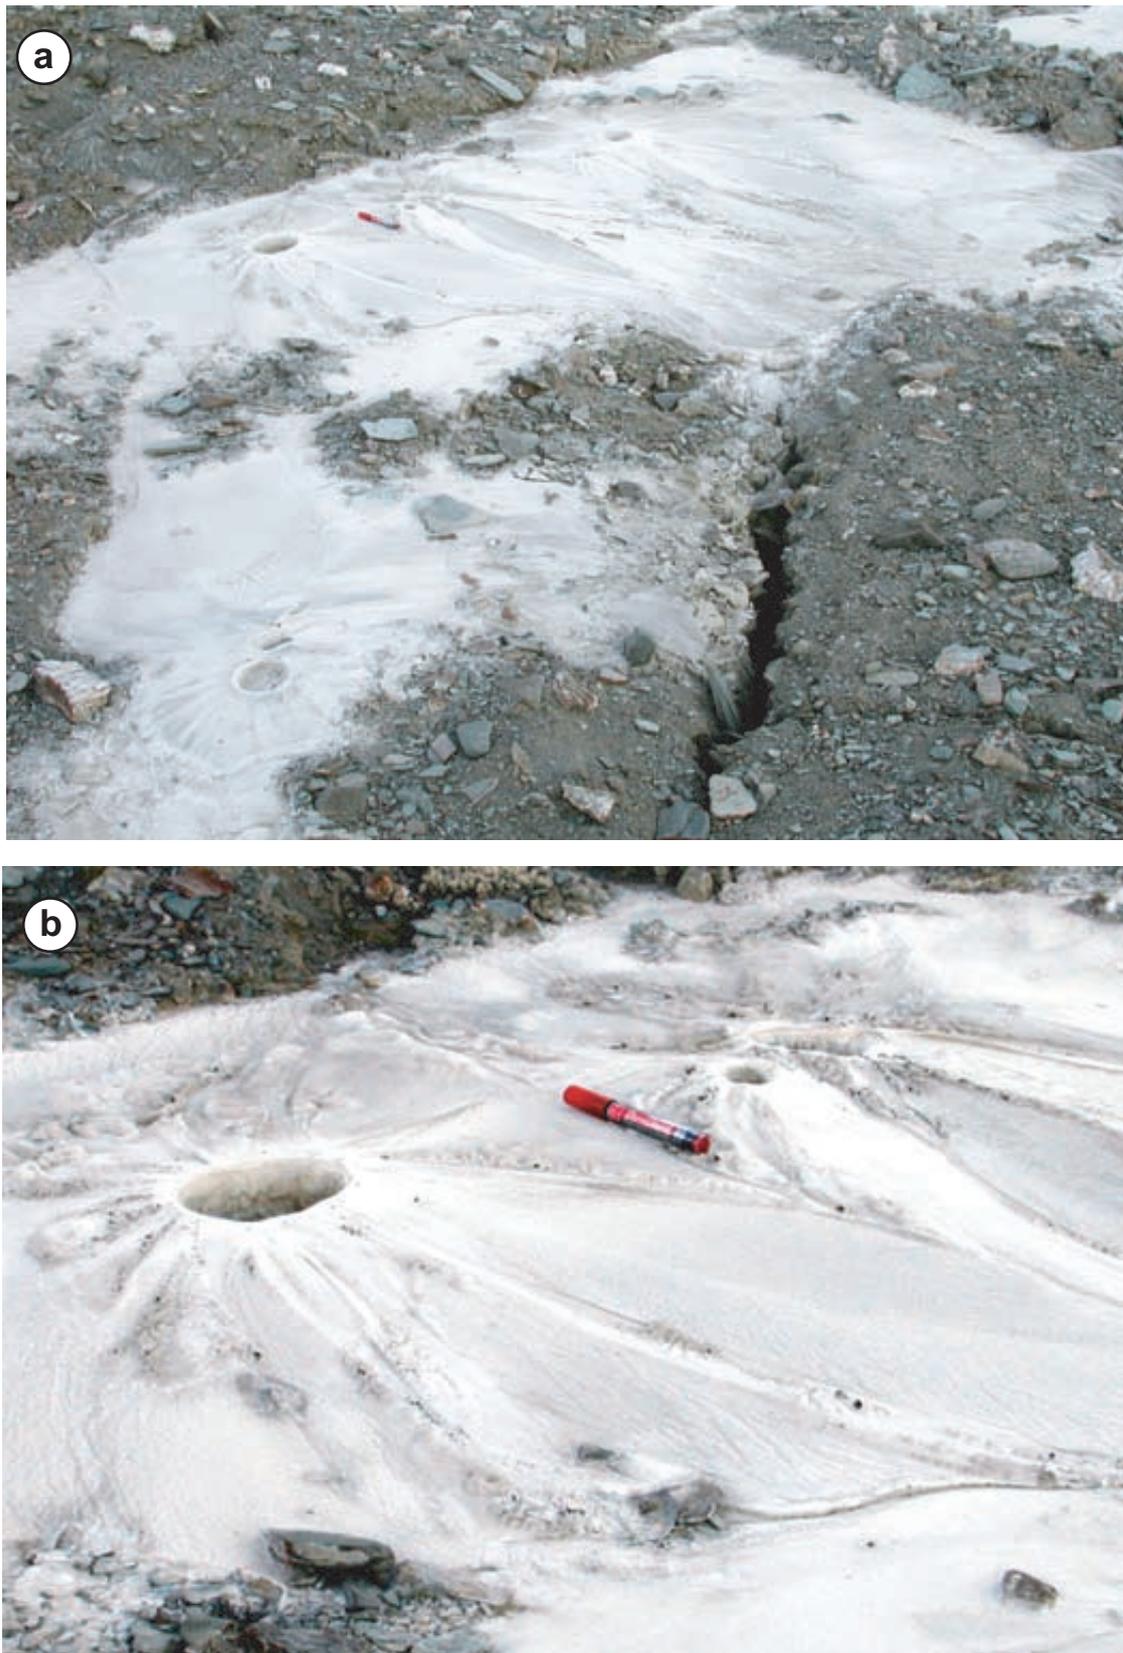
Fig. 10. Ice cones produced by liquefaction on the northern bank of Kusai Lake. (a) Ice cones observed at Site 4. See Fig. 1b for the location. (b) Close-up of ice cones several centimeters in diameter. For the scale see the magic pen.

Sand boil is a common phenomenon that occurs along the surface rupture zone as a result of liquefaction at shallow depth. Sand and water boils produced by liquefaction were found near lakes and stream channels along the surface rupture zone (Fig. 10). Ice cones a few centimeters in diameter were formed because of the temperature below the freezing point (Fig. 10b).
